ACCESSIBILITY AND USABILITY AUDIT REPORT

**INSURANCE REGULATORY AUTHORITY (IRA) ZEP- RE
PLAZA**

REPORT BY: NATIONAL COUNCIL FOR PERSONS WITH DISABILITIES

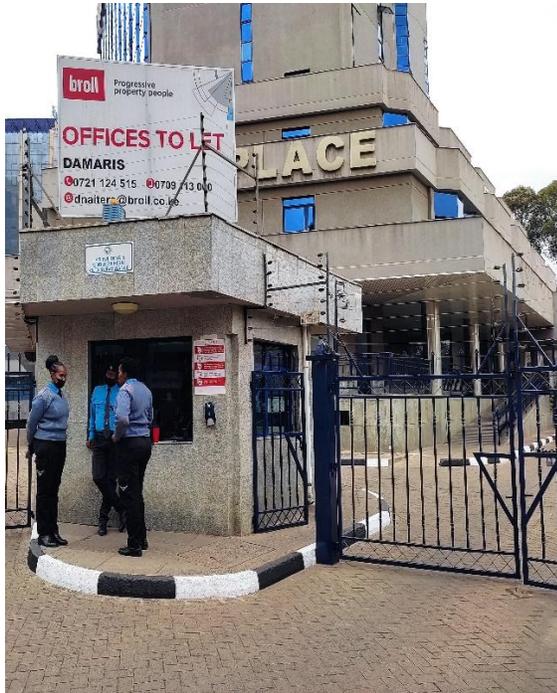
1. During the exercise, the audit team realized that there was a raised Kerb at the pedestrian entrance which is not friendly to wheelchair users.
2. At the main entrance there is no clear signage for IRA logo or wording. The lack of it makes it hard for persons with hearing impairment to access the offices with ease.
3. Security officers at the main gate do not have skills on Kenya Sign Language (KSL) which may be a hindrance to communication especially with those with hearing impairment.

No Signage at the entrance

1. The management should put a large signage on the entrance
2. The security guards should be trained on Kenya Sign Language
3. The drop kerb at the pedestrian should be removed to make it accessible for wheelchair users

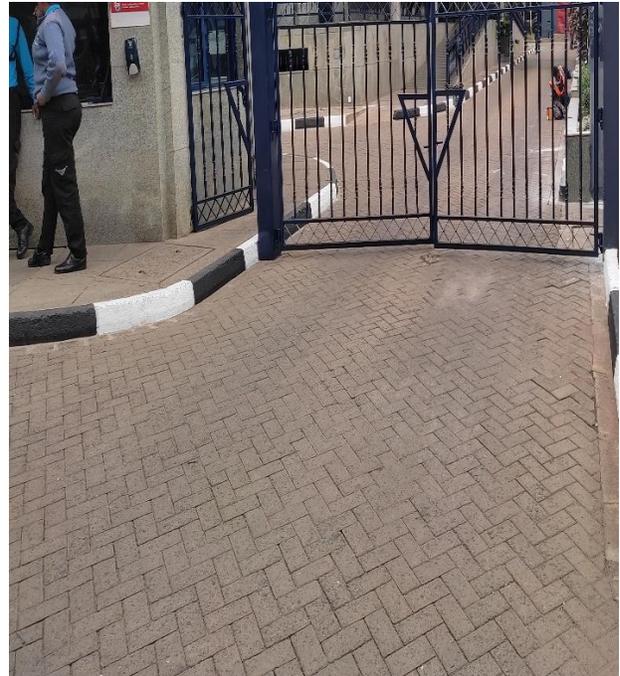
Raised Kerb at the Pedestrian entrance

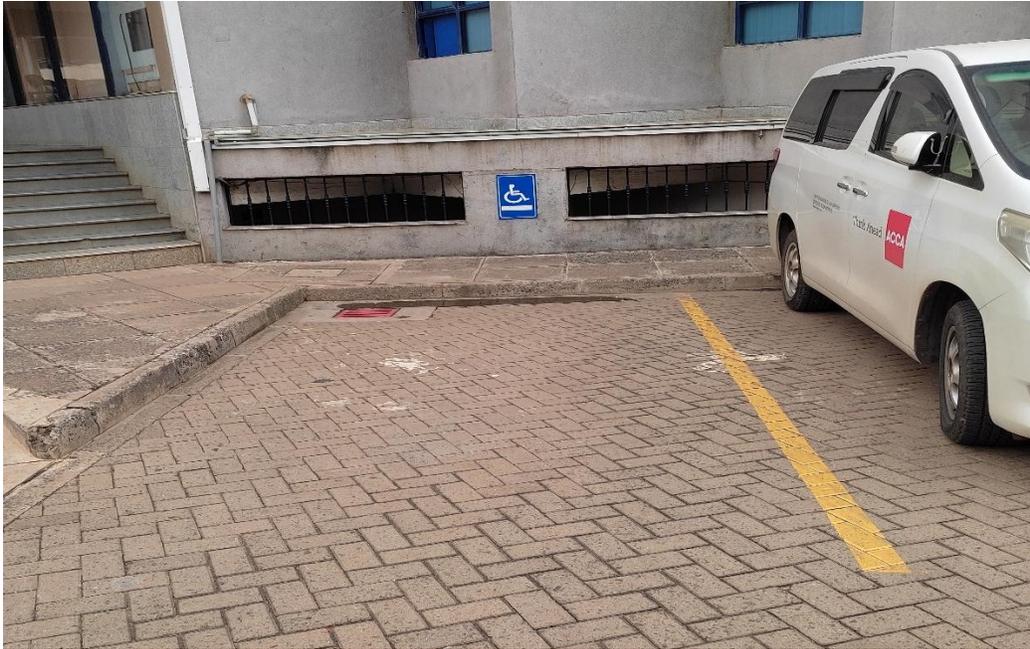
1. Is not accessible since it is not wide enough for persons with disabilities to maneuver and the hand washing area nearby is also an obstruction.
2. The signage should be clearly marked on the floor
3. Currently there is no enforcement on those parking on the reserved parking.

Reserved Parking at the premises

- Designated parking spaces should be located on firm and level ground, as close as is reasonable to the principal accessible entrance to the building with which the parking spaces are associated but no farther than 50meters away from the entrance to the building.
- A parking space designated as one for persons with disability shall have a minimum width of 3.6 m and a minimum length of 4.8 m for perpendicular parking and a minimum length of 6.6 m for parallel parking and with no obstructions.
- Parking spaces shall have an access aisle at least 1500 mm wide along the entire length of the parking space.

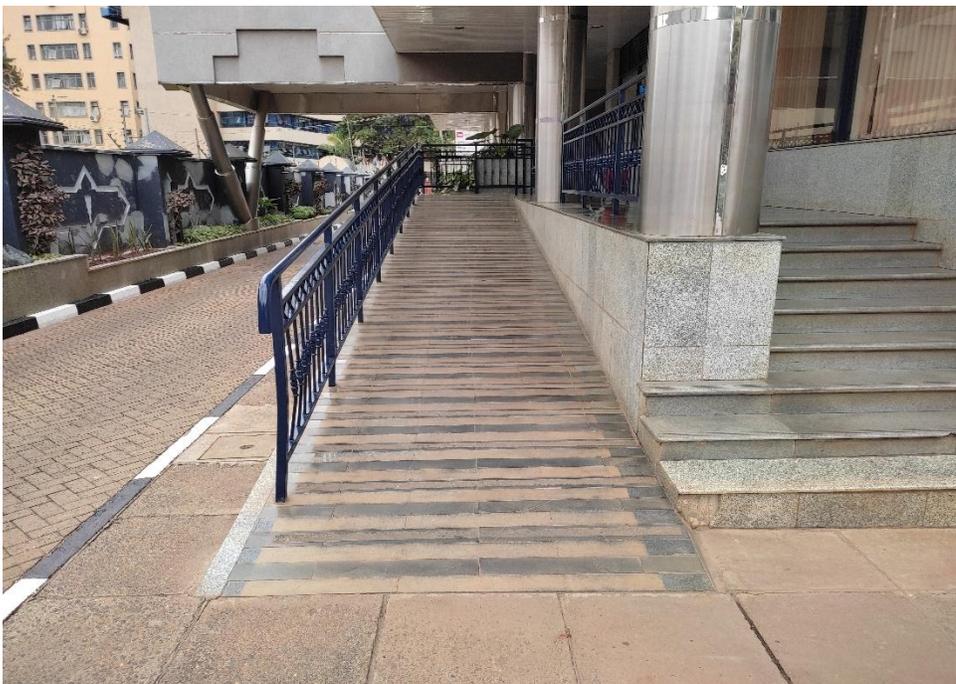
- The ramp has a hand rail on one side which provides proper support for wheelchair and crutches users and it is built on both sides of the entrance of the building.
- The gradient is good hence accessed comfortably by both Persons with Disability and those without disability.

Ramp well done hence accessed with ease

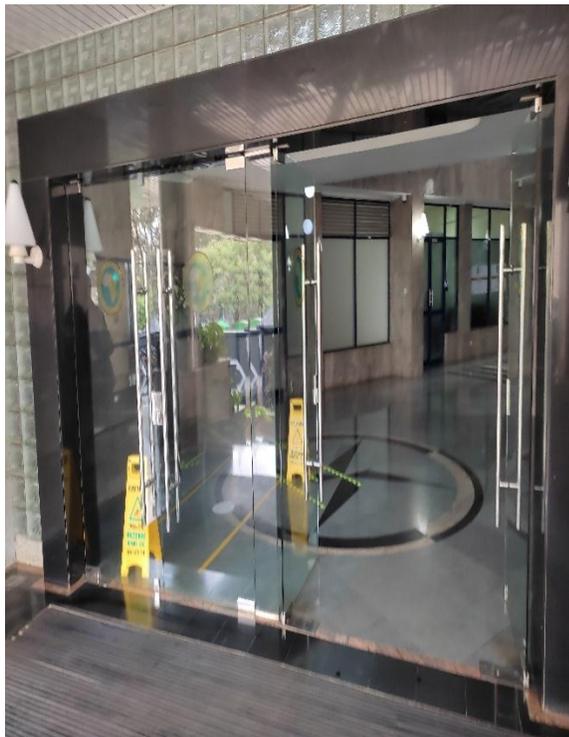
- The main entrance door is made of glass which is not friendly for persons with Visual impairment.
- The door is wide enough
- The floor at the entrance is smooth and slippery and not friendly on those on clutches.
- The height of the reception desk is ok, hence by Persons who uses wheelchair for mobility and those of short stature.
- There is no signage.
- The direction board of offices is in small font and not visible.
- The receptionist is not trained on sign language
- The door is wide enough for a wheelchair user to wheel in and out without difficulties

Main entrance

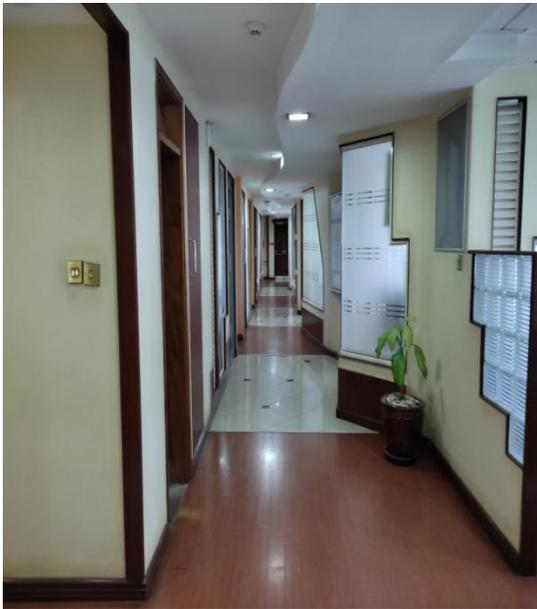
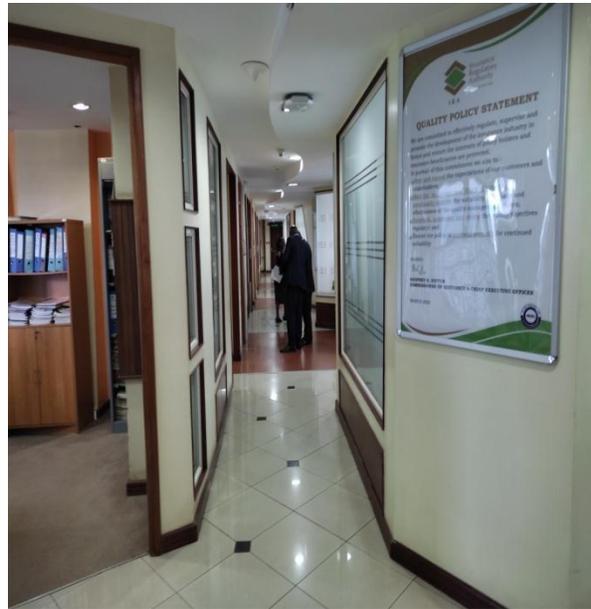
- The corridors in the premises are wide enough,
- The floor is Smooth makes the unfriendly to persons with disabilities.
- The lighting along the corridors is good
- No obstructions e.g. fire extinguishers that are hazard to persons with visual impairment

Corridors wide enough but with smooth floor

- Carpeting of the floor to make it disability friendly

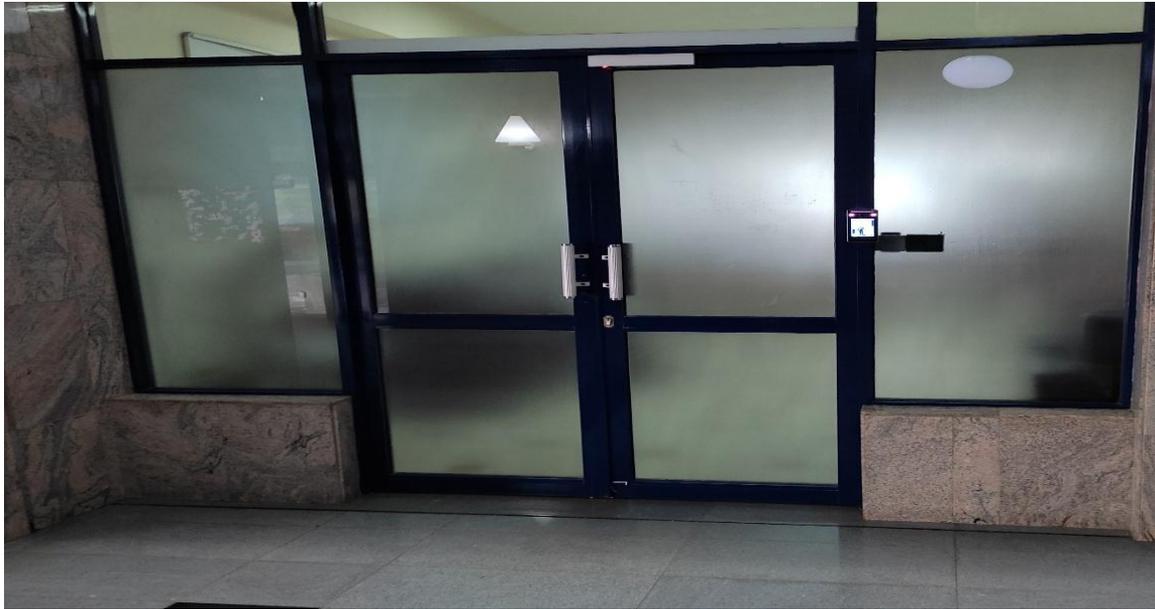
- The floor is smooth and slippery
- The door the is wide enough
- The door has an automatic sensor but hard to open
- No emergency exit doors
- No fire extinguisher
- No clear signage

Entrance Consumer Protection office (No Signage)

- The floor should be carpeted to reduce the risk of falling and getting injured and this applies to all (those with disabilities and those without).
- There should be a signage at the entrance to ease directing of clients.

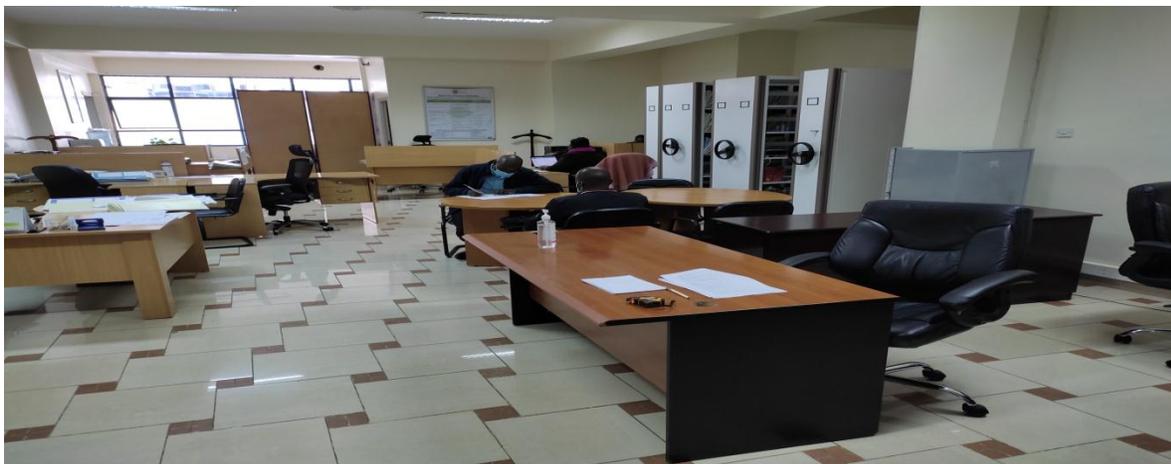
Consumer protection office

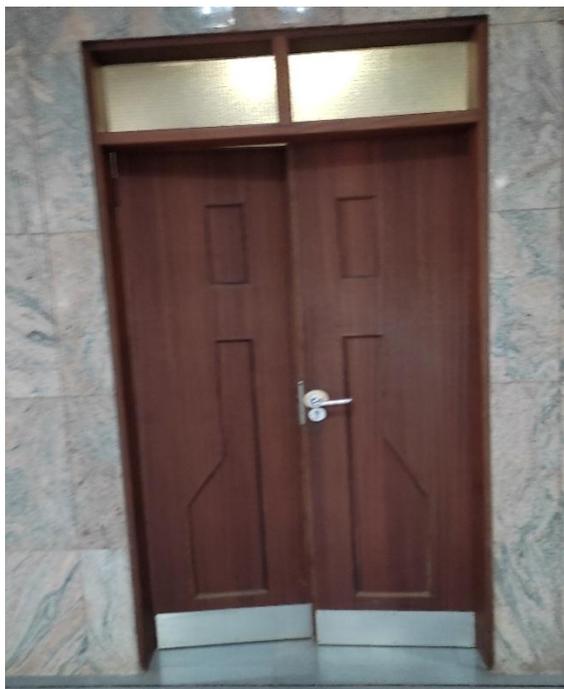
- There is no signage at the corridor leading to the washroom
- The toilet door is well signed.
- The corridor is wide enough but the floor is slippery
- The accessible washroom is good though it does not have a sanitary disposing bin
- The sinks and drier are lowly placed which is useable to persons of short stature and wheelchair users.

Door to washroom with no Signage

- Signage at the corridor leading to the washrooms
- Carpeting of the floor
-
- Place the sanitary disposing bin and we recommend the one with a sensor so that it can be used with those without legs and also those without hands or those who lack both
- The condom dispenser should be placed at a level accessible to persons on wheelchairs and those of short stature

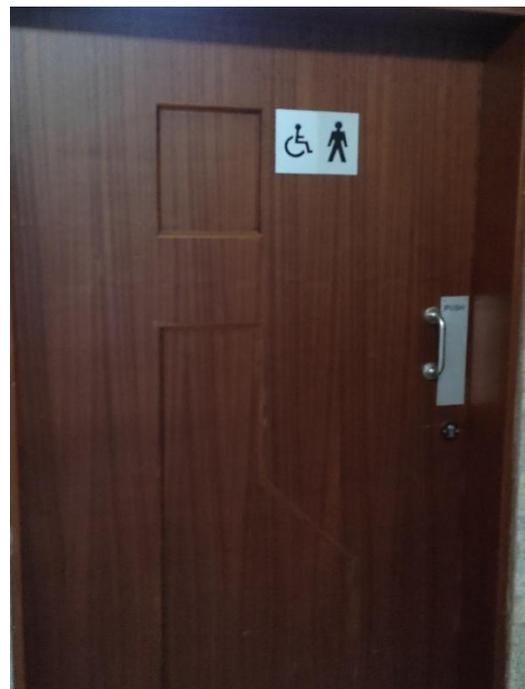
well labeled washroom door

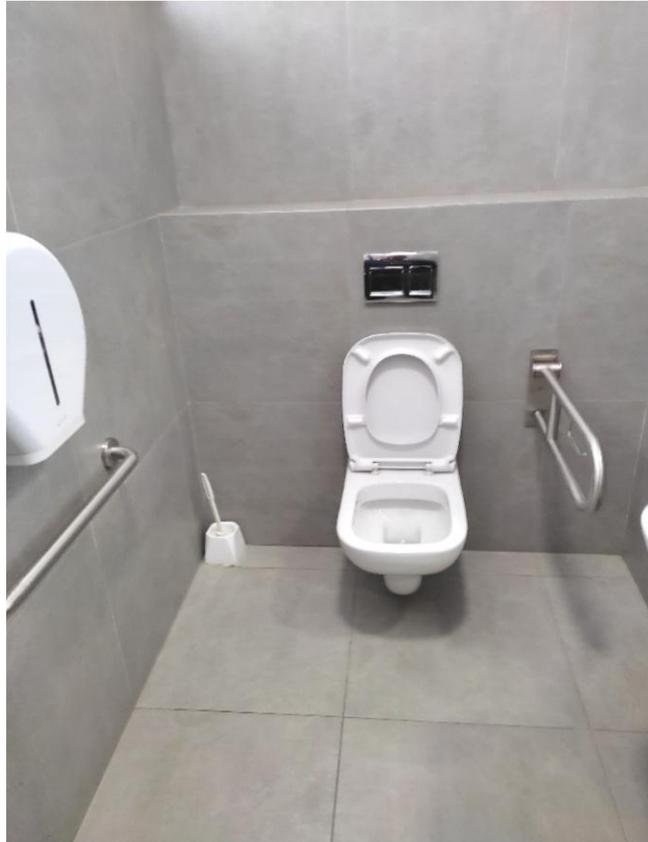
Accessible washroom

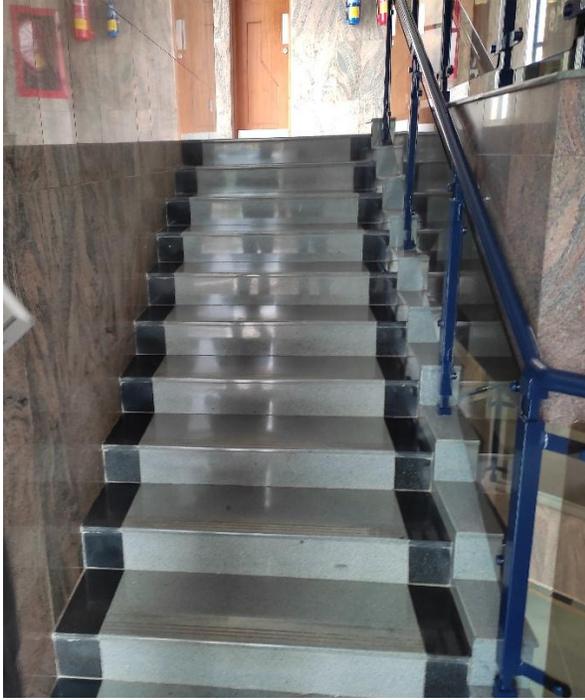
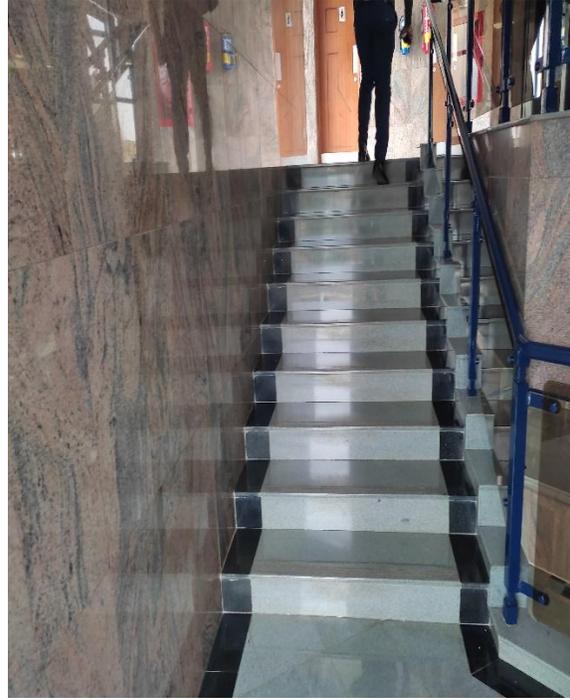
- The intermediate handrail is installed.
- The location of the stairs is clearly identifiable
- The treads have a slip surface, this is not friendly for mobility for those using crutches and other mobility devices.
- The stairs are equal in number which is friendly for persons with visual impairment.

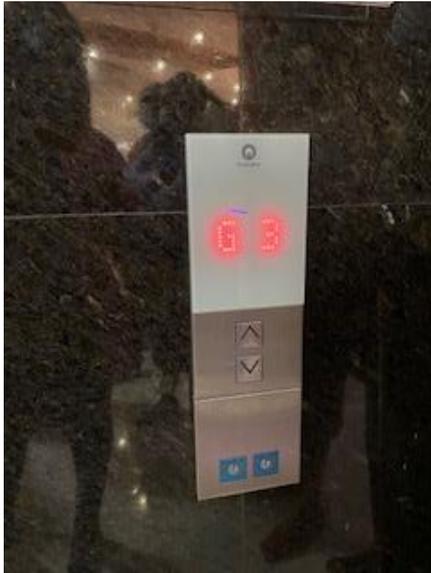
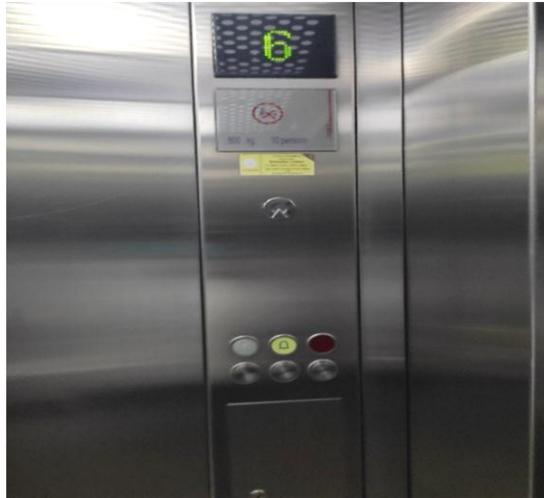
- The lift is wide enough hence ease to maneuver inside and even when getting inside and outside
- Not Installed with tactile buttons
- Not installed with voice

Lifts without tactile buttons and voice system

- Install the system with voice and tactile buttons to enable persons with visual impairment use the lift independently or with minimum guidance

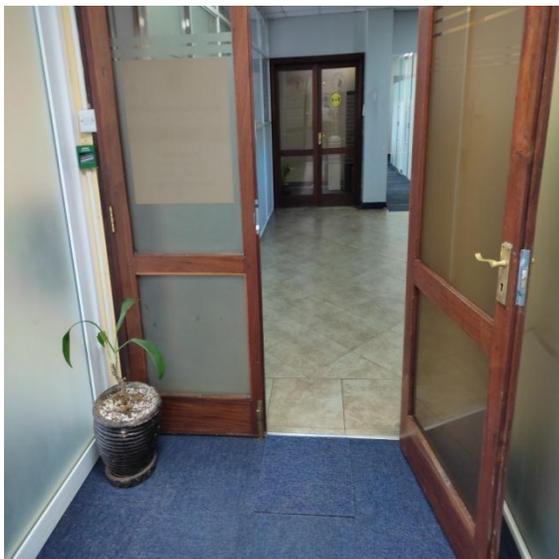
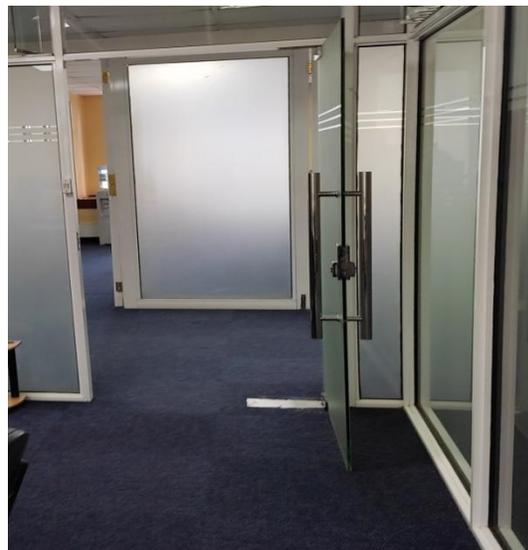
The doors at IRA range from 770 mm to 970 mm for the single doors and 1100mm to 1940mm for the double doors. The door handles range from 1000mm – 1300mm for the double doors. Most of the door knobs are not suitable for persons with disabilities.

- The doors should be made to the standard width of 900mm and a minimum of 850mm and with locks which can be opened with closed fists.
- All the door locks are of the recommended size and are 1030mm from the ground which is suitable for persons using wheelchairs and of short stature.
- The office doors have signage for specific departments as shown above.

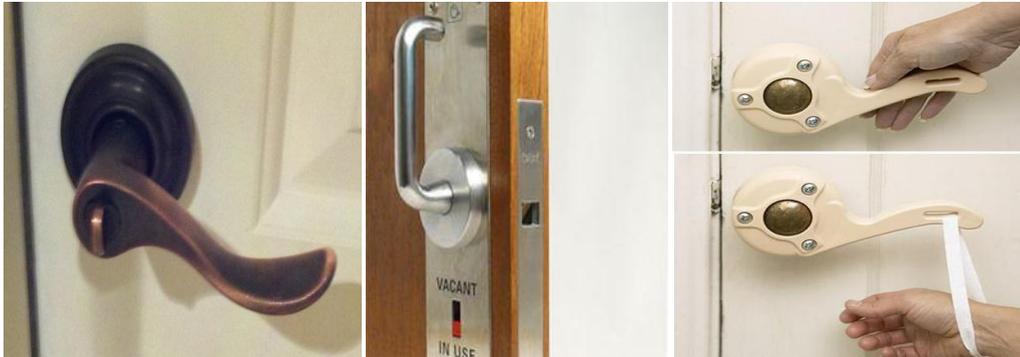
Illustration of Door knobs suitable for use by Persons with Disabilities

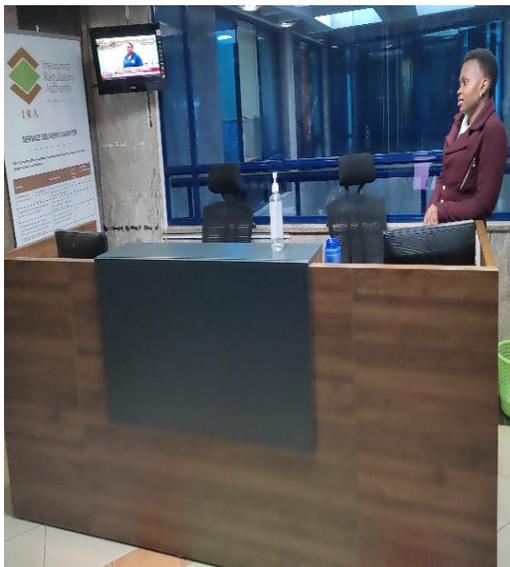
- There is no signage hence making it difficult to identify it.
- Entrance door is made of glass which is not disability friendly
- The reception Counter is highly placed.
- Receptionist not trained on sign language
- Small Tv at the reception with no broadcast on Authority services
- Smooth and Slippery floor
- Limited working space for mobility with a wheel chair
- Poor cabling within the working stations
- Lighting switches highly placed
- Door locks highly placed
- Serving counter at the Records office is highly placed
- The glass at the service counter (records office) also limits sound movement
- The fire alarm has the siren
- Fire alarm lowly placed, friendly for wheelchair users
- Evacuation zone is near the accessible entrance

Unfriendly Reception Desk

- We recommend that the Authority to put the signage for ease identification of offices.
- Carpeting of floors to make them friendly for clients and staff using clutches
- Redesign the reception counter
- Larger TV screen at the reception with sound and subtitle on Authority services
- Train reception attendants on Sign language
- Have an accessible washroom

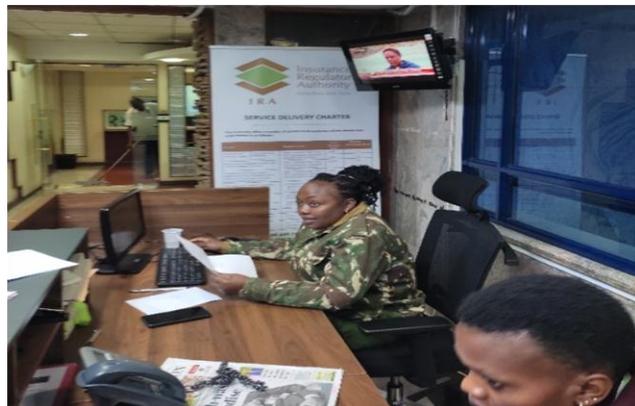
poorly placed service charter

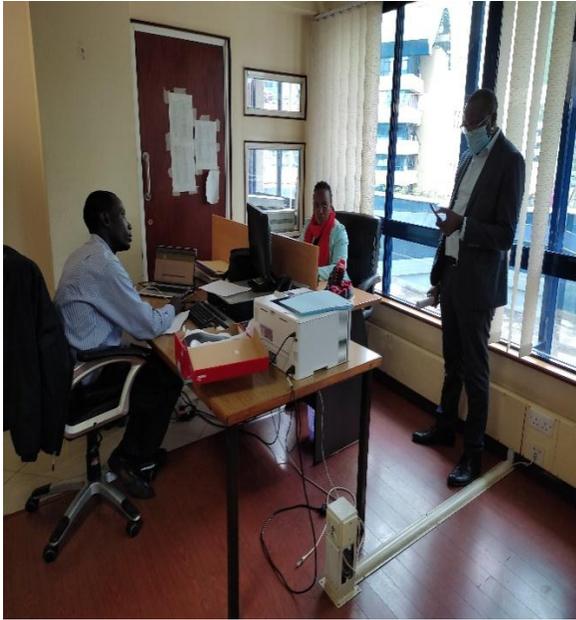
Obstruction on the working space

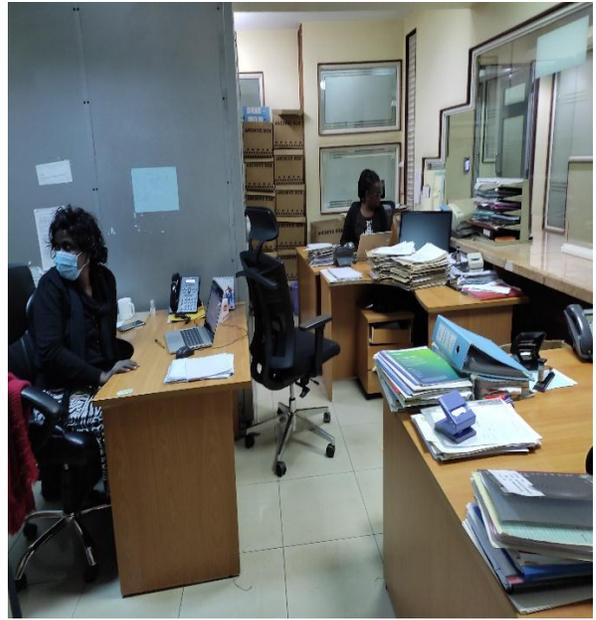
Limited spaces for mobility

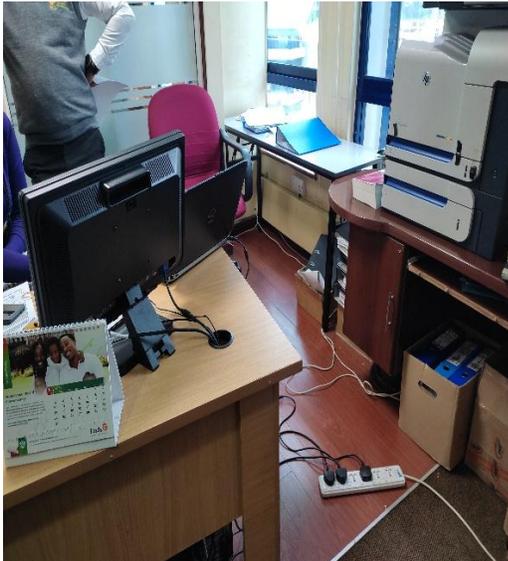
Poor cabling within the office

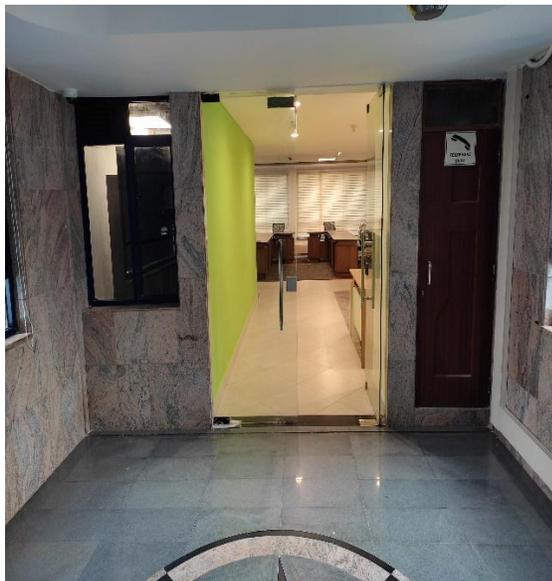
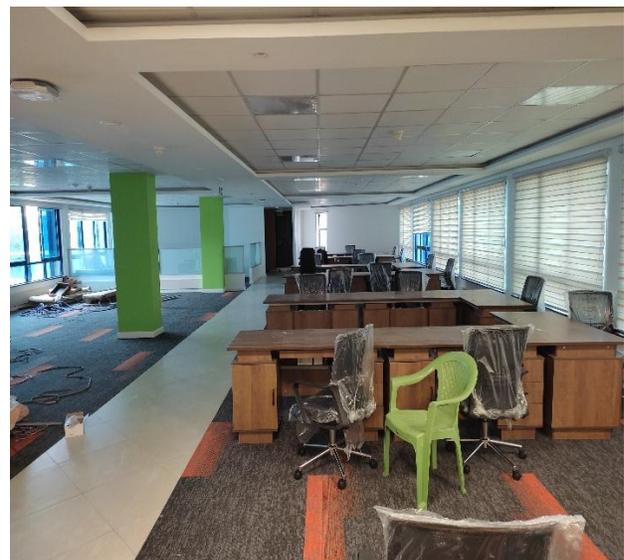
- The floor has a new office which is being set up
- Floor entrance is slippery
- No signage at the entrance
- Door is made of glass which is not friendly
- Highly placed lighting Switches
- Slippery floor at the center

slipery entrance / No signage./Spacious office / splipery centre

- The chairs should be firm without rollers at the bottom
- Signage of the entrance
- Non slip floor at the entrance
- Tinting of glass doors to make them visible

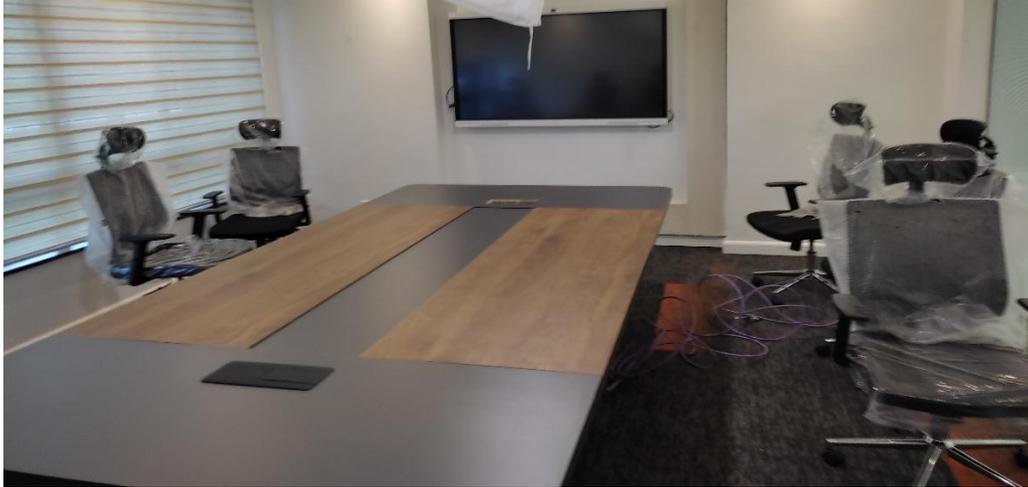
- Good cabling
- Wide doors
- Floor is carpeted
- The chairs are not stable

Spacious boardroom with movable chairs

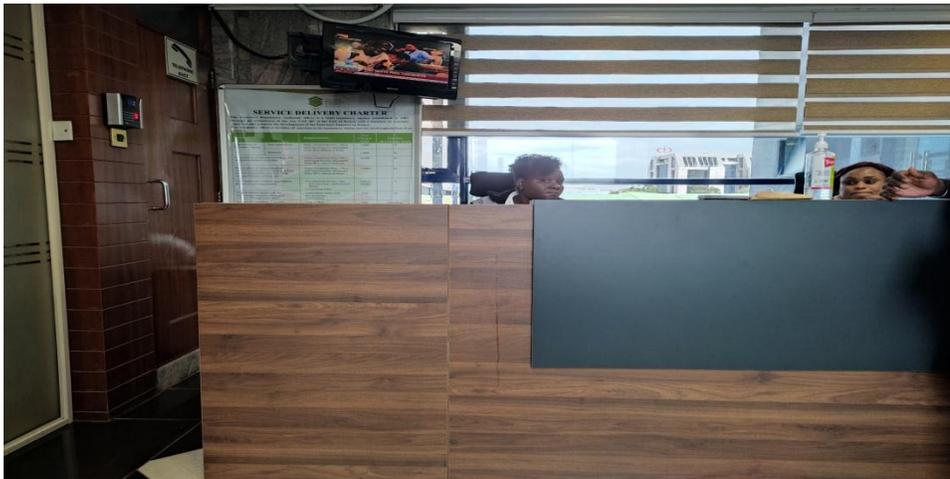
- The tiles are smooth and slippery
- The entrance door is wide enough
- The reception desk is highly placed
- Service charter poorly positioned
- No sign language interpretation at the reception

Current reception desk

- The clear maneuvering space in front of a counter or reception desk or similar fittings should accommodate a turning circle of 1500 mm diameter.
- A high seat or stool should be provided so that people with limited standing ability can use both hands for a transaction

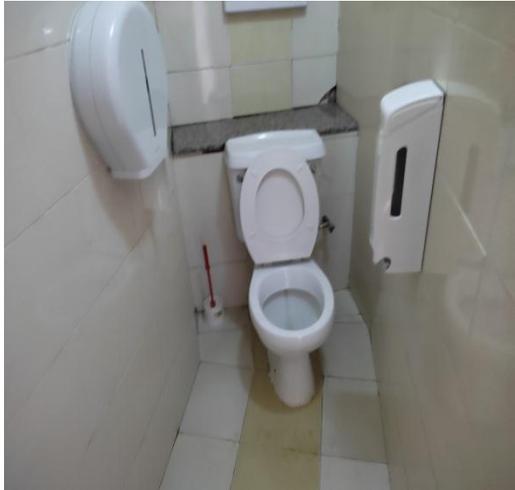
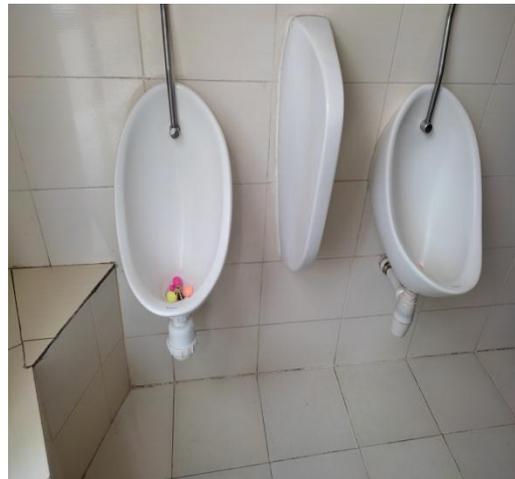
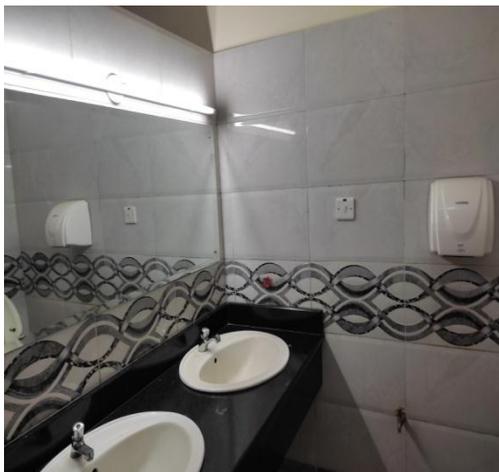
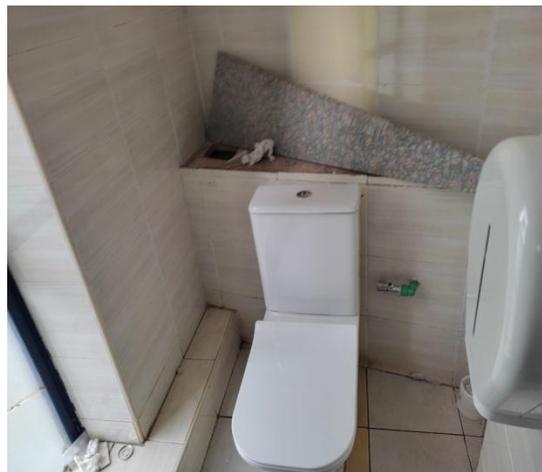
- There are washrooms on all floors for both ladies and gents including none are accessible to PWDs in the upper floors.
- The corridor to the ground floor washrooms is very narrow
- The tissues, hand driers and condom dispensers are highly placed and inaccessible to PWDs.

- There should be an accessible washroom in every floor both for ladies and gents and built in the specifications as per the illustrations for accessible

washroom derived from KS ISO 21542 – accessibility and usability of the built environment.

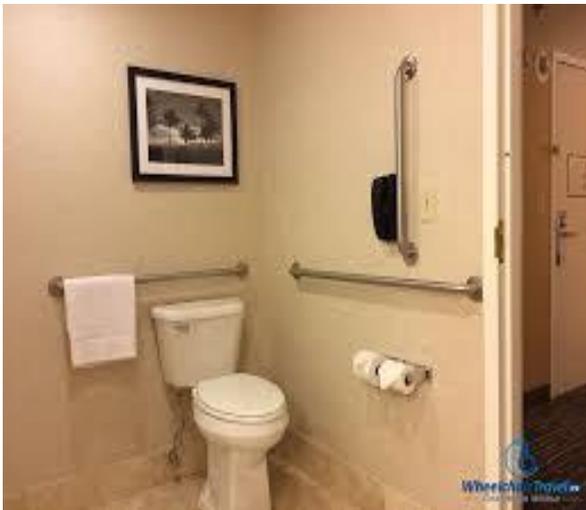
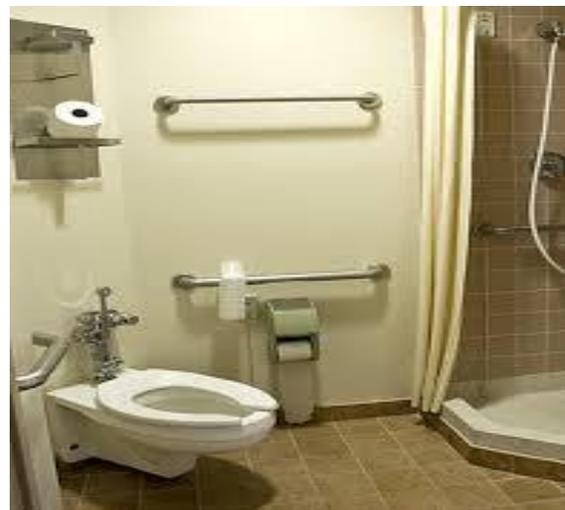
• (Pic: sample accessible washrooms)

- When wall hung urinals are fitted in the washroom, it is recommended that at least one of these have its rim set at a height of 380 mm for wheelchair users and at least one has its rim set at a height of 500 mm for standing users. When installed, both should be equipped with a vertical grab rail. Urinals should contrast visually with the wall to which they are attached.

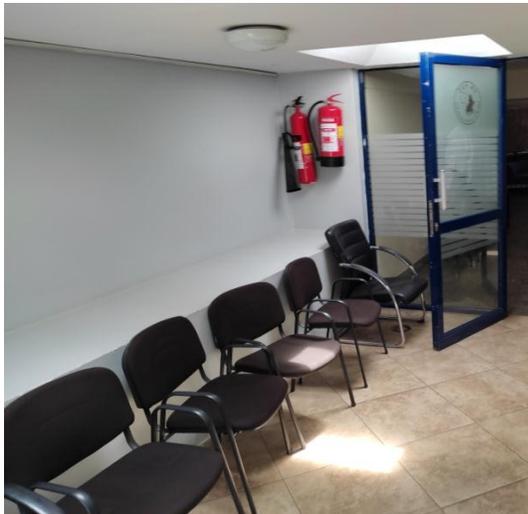
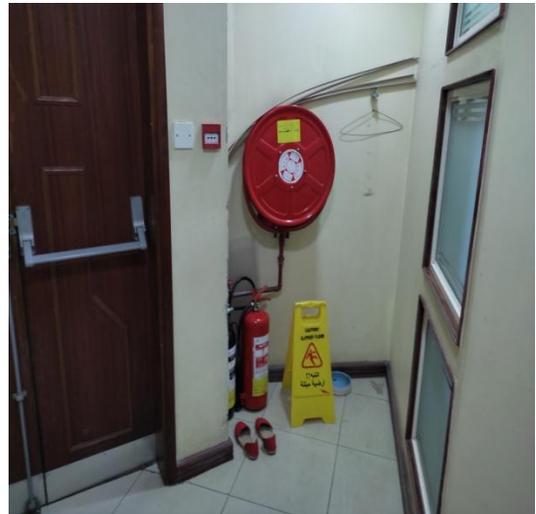
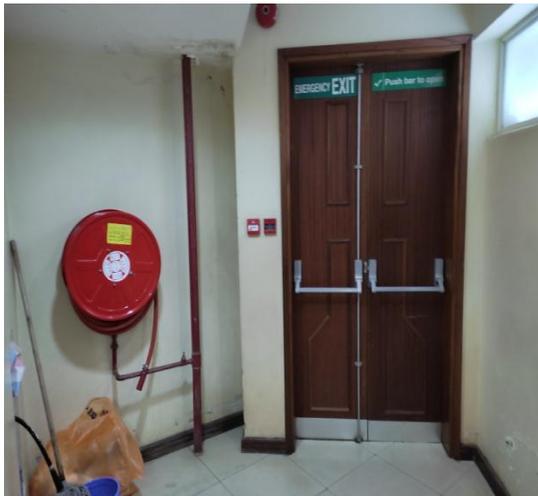
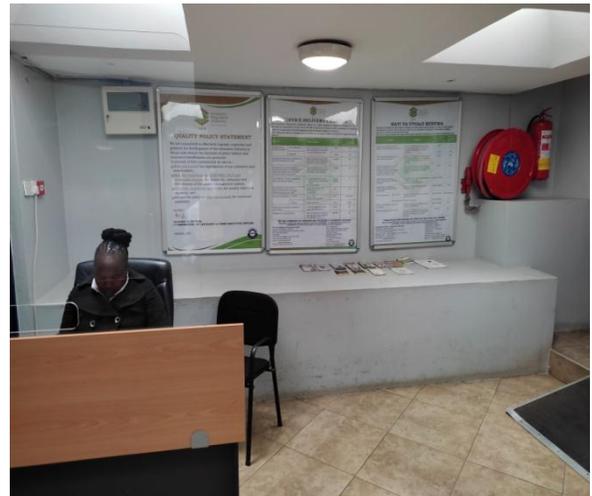
The building has fire extinguishers which are placed high various heights with a fire horse installed too. Some are inaccessible to PWDs with as shown below:

- Fire extinguisher cylinders should be placed in a position that does not pose a hazard to persons with disabilities.

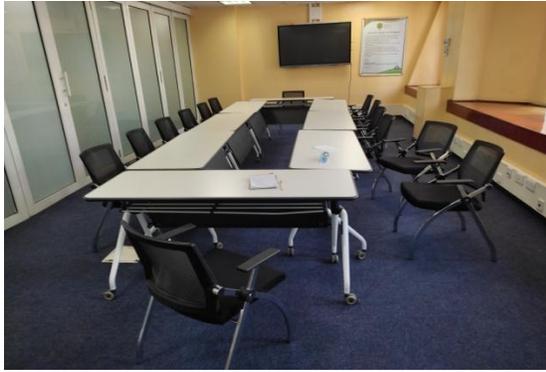
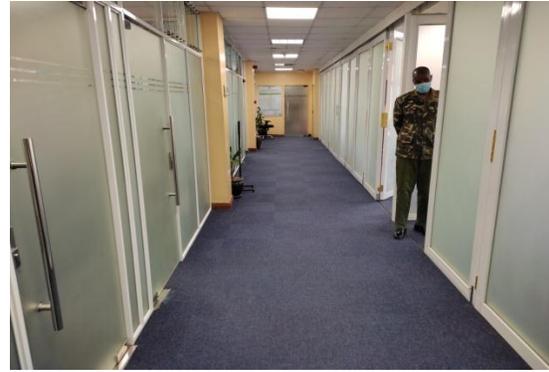
- The room is spacious and chairs are stable
- The lighting is adequate hence good for Persons with loss vision
- The floor is carpeted and friendly for persons with Disabilities.
